National Register of Historic Places Registration Form

Historic Name: Brownsville Freight Depot and Warehouse District

Other name/site number: St. Louis, Brownsville & Mexico Railway Company Freight Depot

Brownsville Freight Depot and Warehouse District, Brownsville, Cameron County, Texas

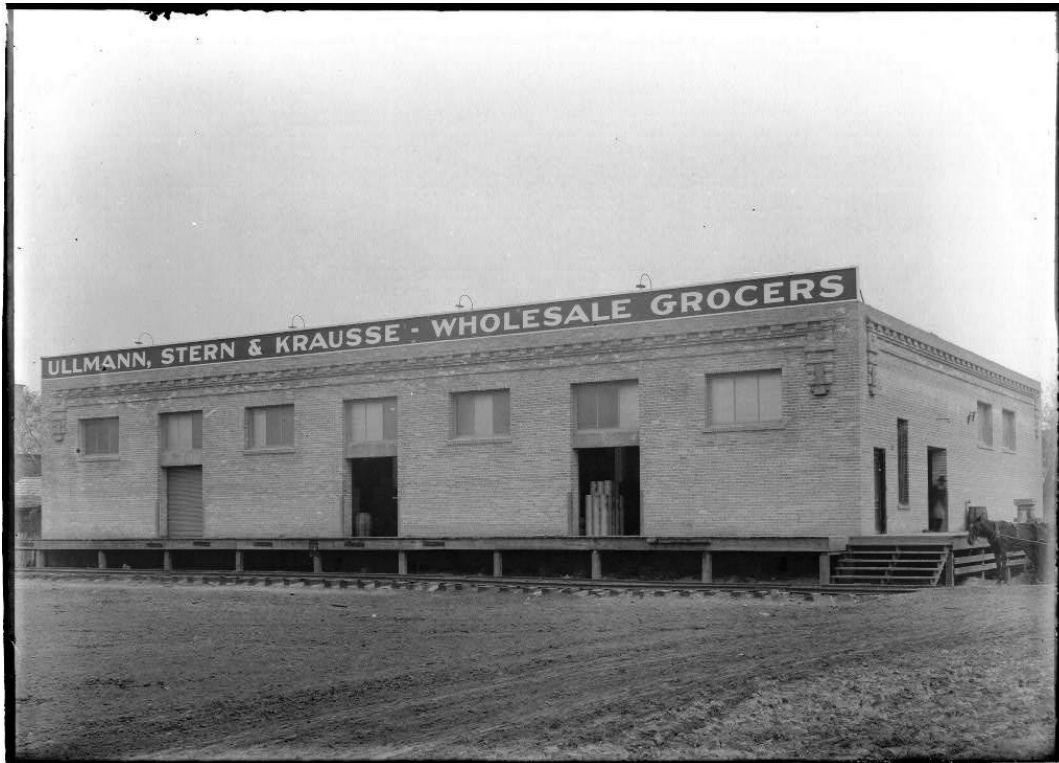
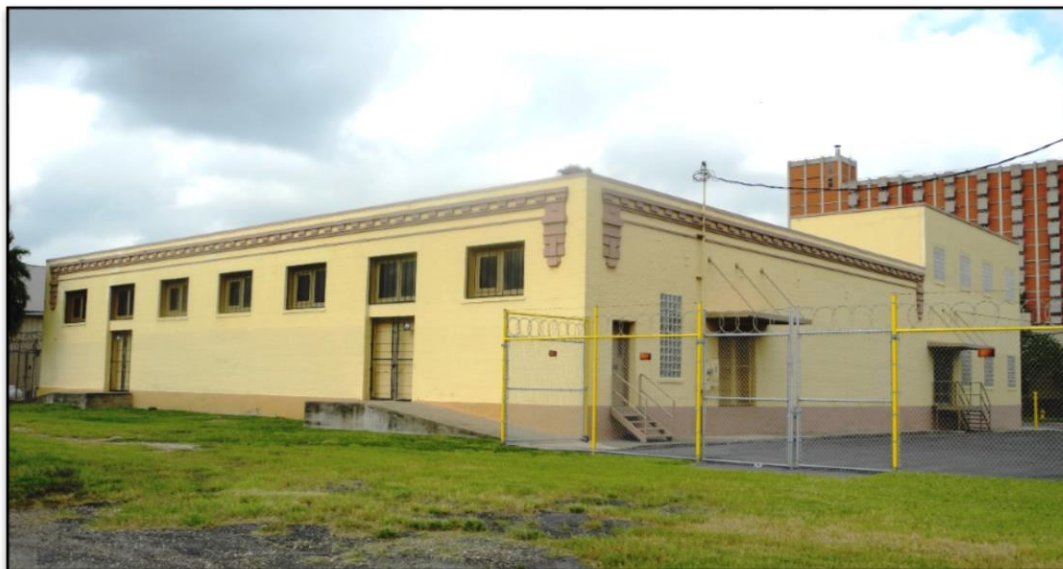
FIGURE 3: Ullmann, Stern & Krausse grocery warehouse (Resource 12). Photo by Robert Runyon, 1912. Image provided by Harry E. McNair, Jr. Original at Center for American History, University of Texas at Austin. [current photo at bottom (2017)].

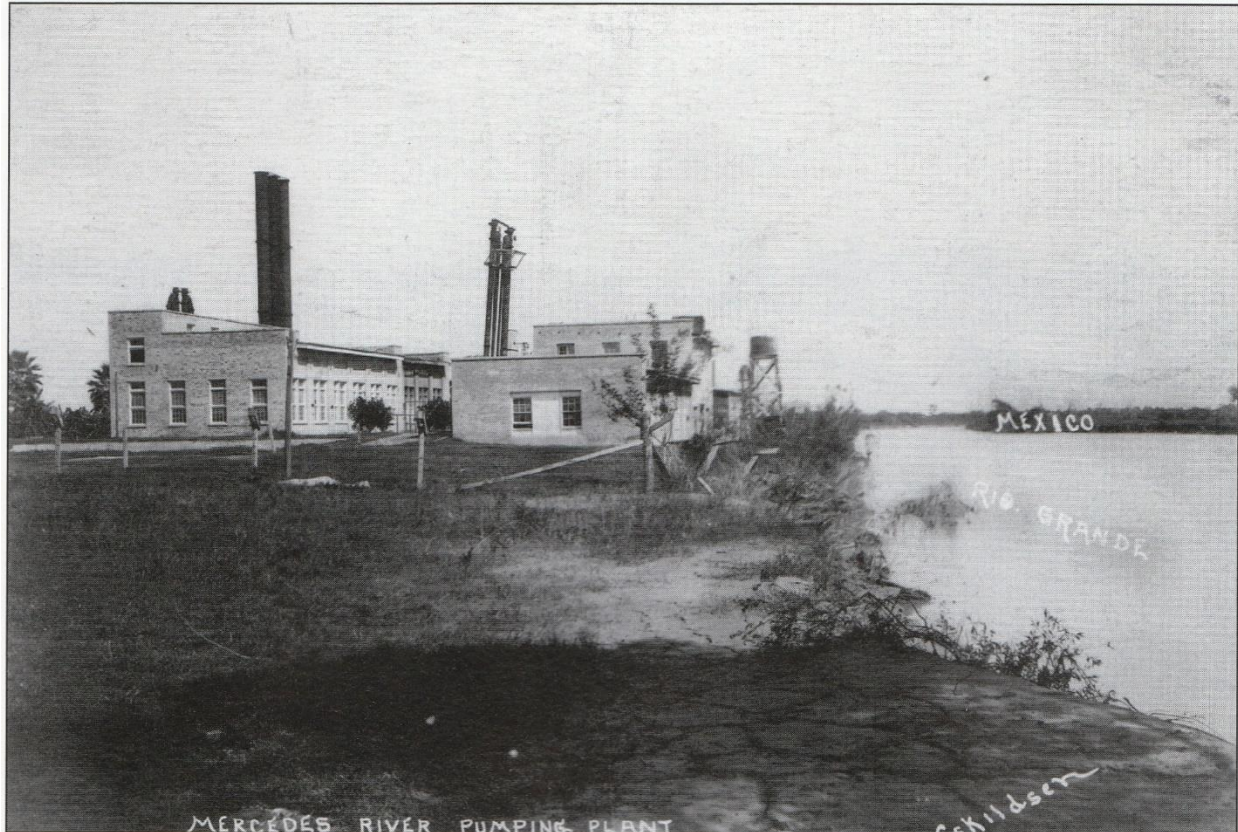
FIGURE 14: Mercedes Irrigation Pump House, in Gerhardt and Santa Ana III, 2000.

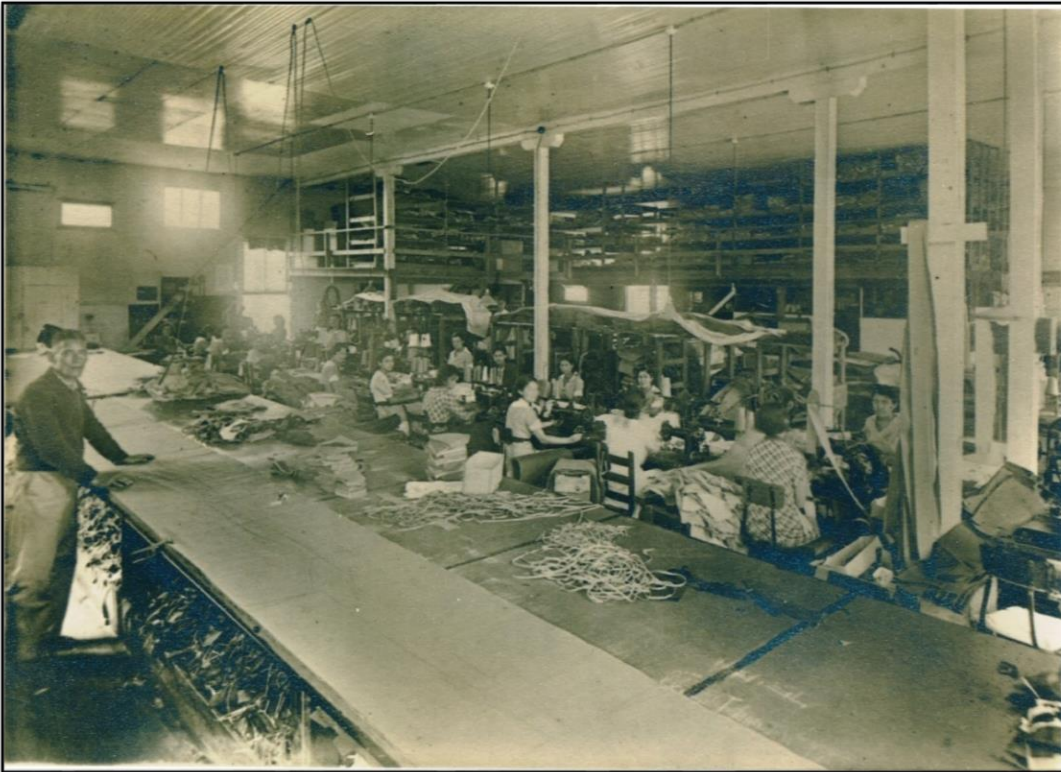
FIGURE 28: McNair Shirt Factory (Resource 14, 759 E. Fronton), early 20th century photo in collection of Harry E. McNair, Jr. Note wood support brackets (See Photo 41).

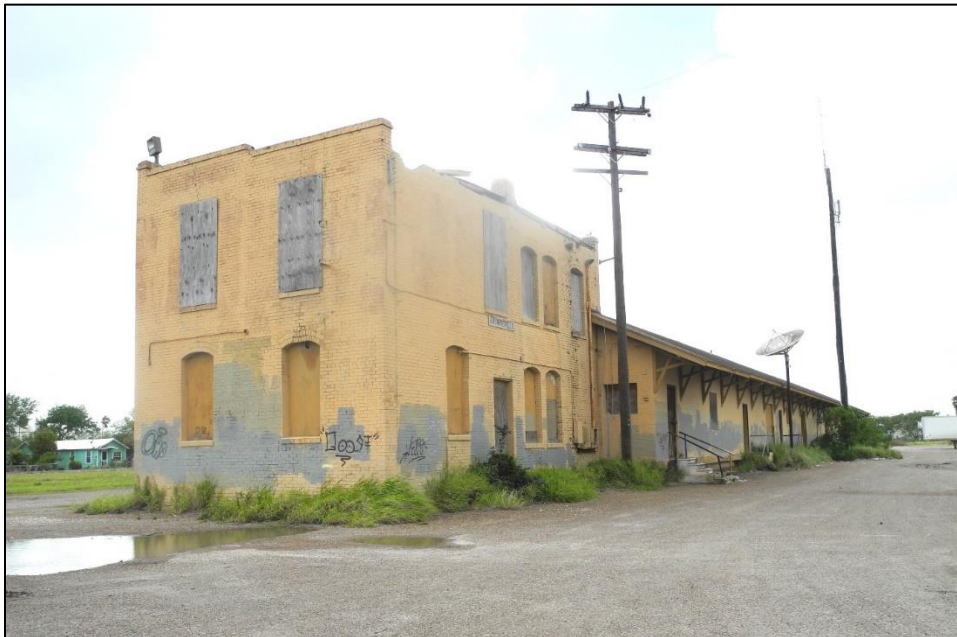
PHOTO 2: St. Louis, Brownsville & Mexico Railway Co. Depot Office (left) and Freight Depot (right), (Resources 2 and 1), side/east and rear/north elevations, facing northwest.

The freight depot office is connected to the east end of the freight depot, but has a different height, massing, and style and reads as a separate building. The depot office was constructed in early 1911 to support the business of the original St. Louis, Brownsville & Mexico freight depot built in 1904. That depot burned in 1911 and was replaced by the existing depot completed in February 1912. The depot office is a two-story building with brick walls and a low-pitched shed roof that appears flat. Its primary elevation faces south toward the former location of the St. Louis, Brownsville & Mexico Railway Co. train tracks. The building's low parapet is more pronounced on the south (front) elevation. It steps down in height along the side elevations until it disappears along the rear (north) elevation where water drains from the slightly-sloping roof. Brickwork provides subtle decorative detail—the bond pattern on the walls consists of a row of header bricks in between every five rows of stretcher bricks, and the window and door openings have brick segmental-arch headers and brick sills. All door and window openings are currently boarded with plywood but the fenestration pattern and arched headers are still evident. The building has minor brick damage at the front parapet and rear roofline. Despite minor alterations and deterioration caused by neglect, the depot office possesses good integrity and is able to convey its historic significance.

The depot office is a good, relatively intact example of a two-part commercial building designed and built in the regional vernacular of the period. It is a handmade brick building with a flat roof, low parapet, and bands of segmental-arch windows and doors typical of early twentieth century commercial buildings in towns along the lower Rio Grande. Though its historic windows and doors have been infilled with plywood, they are clearly visible and convey their form and design well. The infill can be easily removed and the windows replaced. The building retains a good degree of historic and architectural integrity and is a contributing resource in the district.

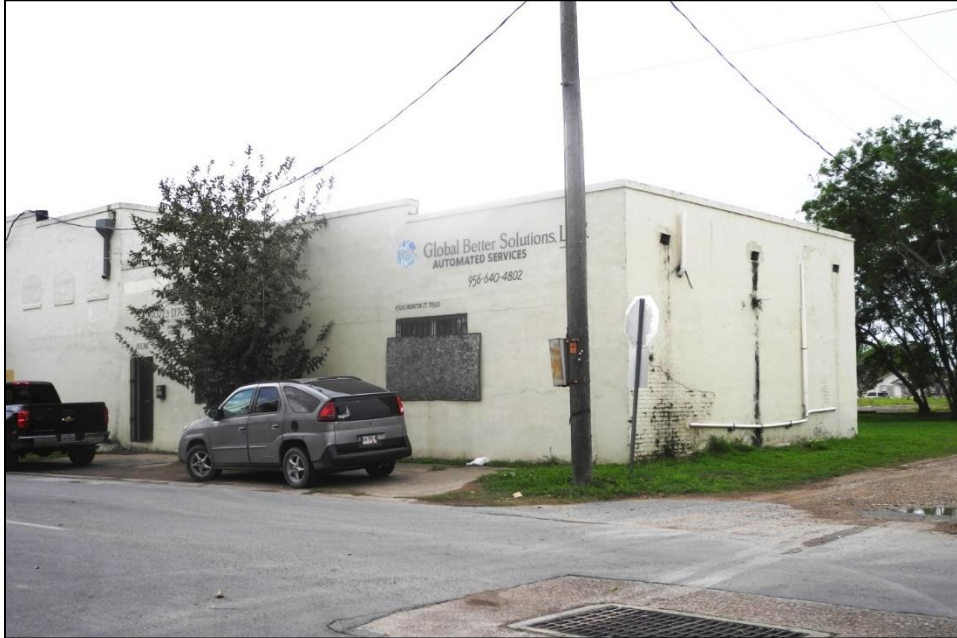
PHOTO 13: 430B E. Fronton Street (Resource 3), side and front/north elevations, facing south.

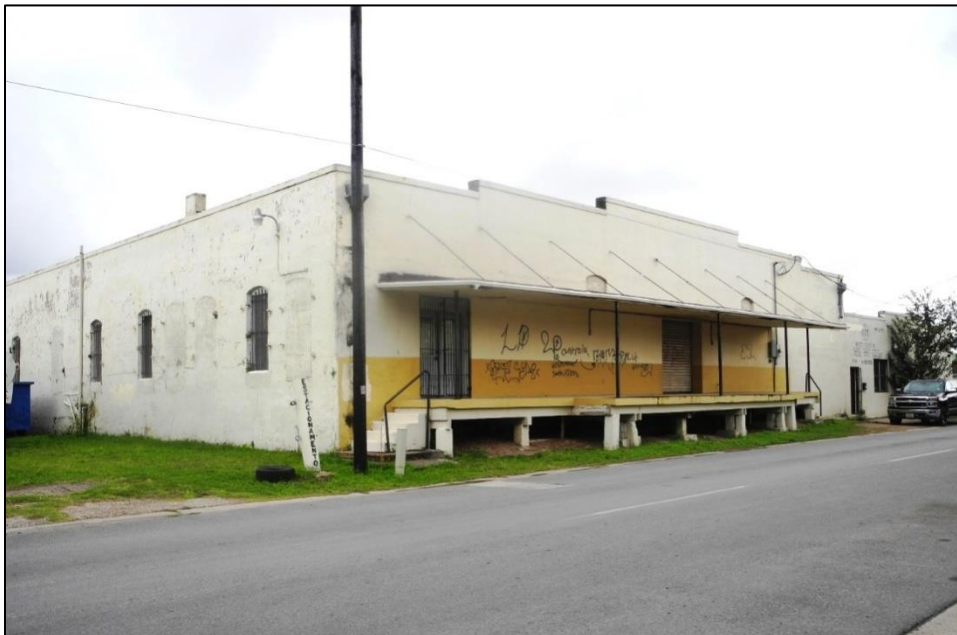
PHOTO 14: 430A E. Fronton Street (Resource 4), side and front/north elevations, facing west.

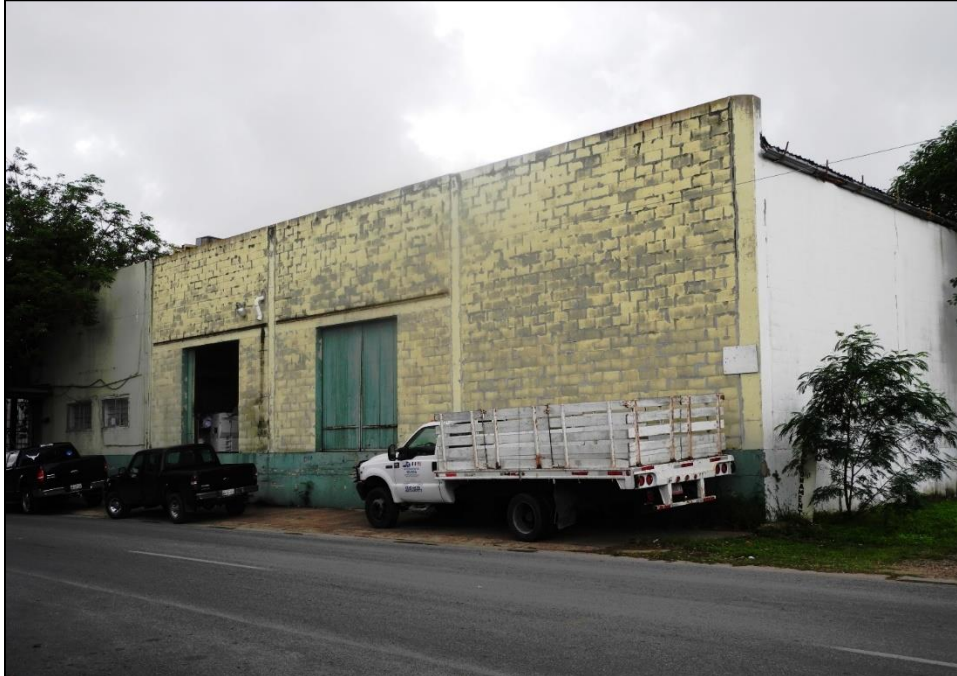
PHOTO 15: 454 E. Fronton Street (Resource 5), front/north and west elevations, facing south.

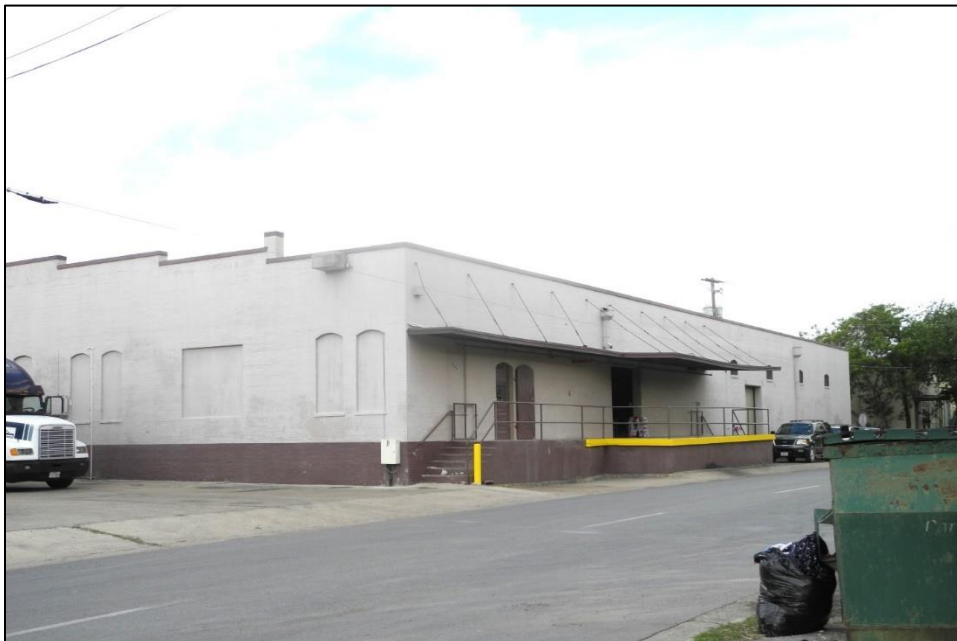
PHOTO 16: 504 E. Fronton Street (Resource 6), east and front/north elevations, facing west.

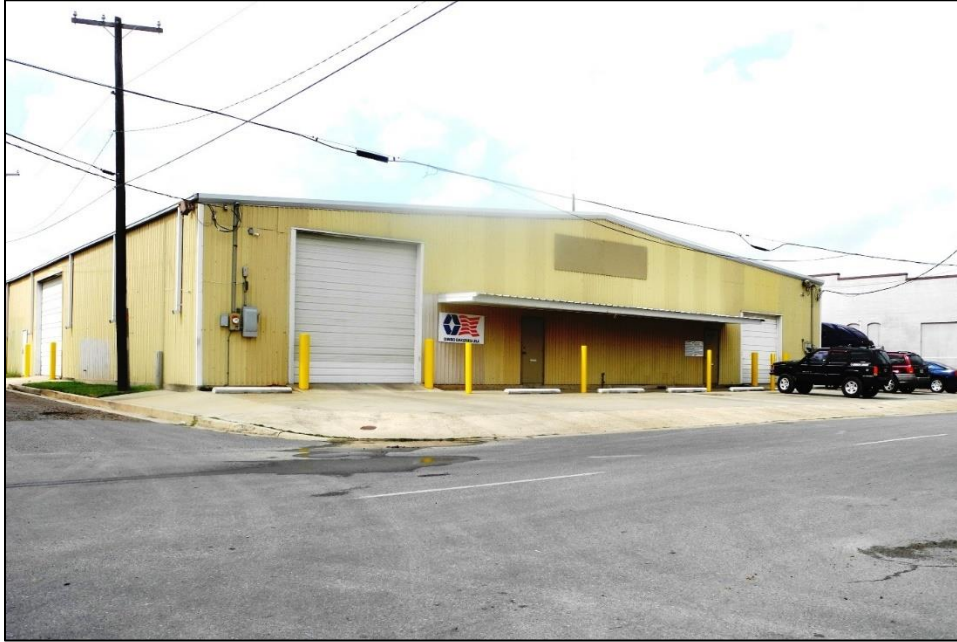
PHOTO 17: 534 E. Fronton Street (Resource 7), side/east and front/north facing west.

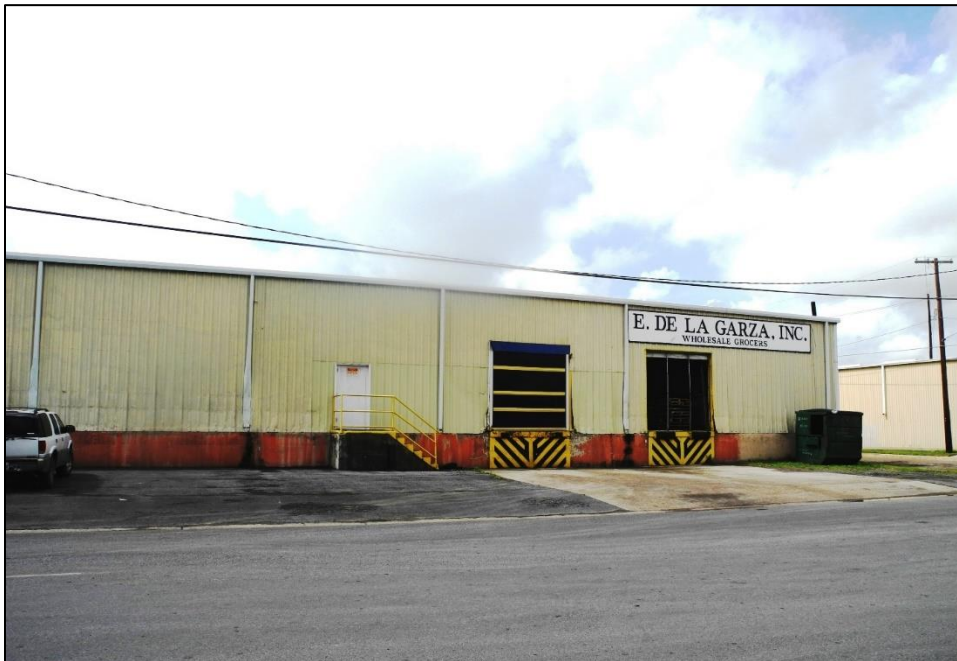
PHOTO 18: 600 block E. Fronton Street (Resource 8), front/north elevation, facing west.

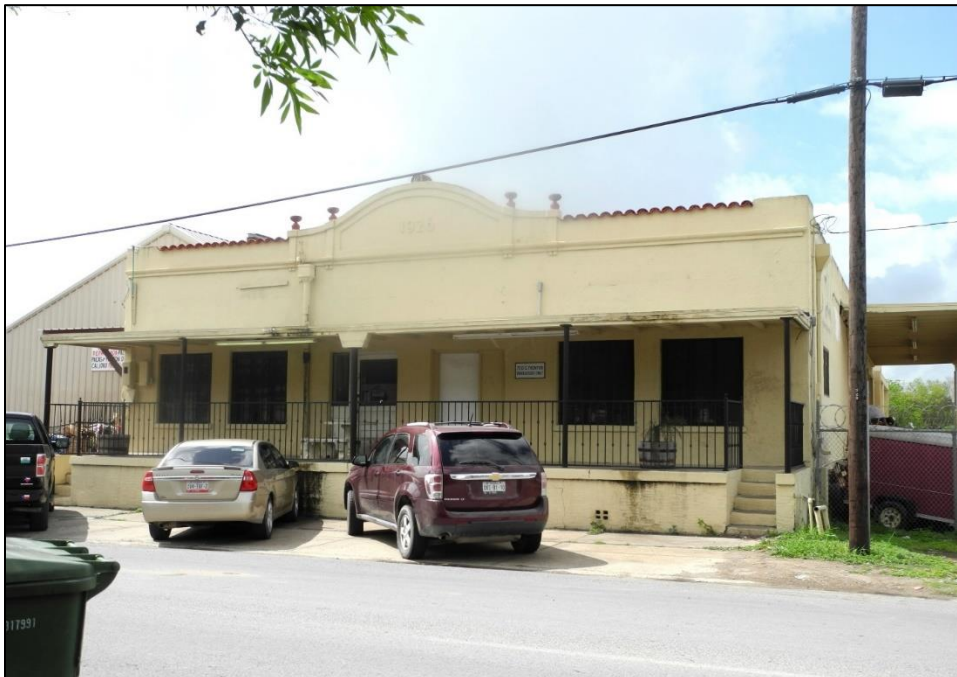
PHOTO 20: 720 E. Fronton Street (Resource 10), front/north elevations, facing south.

The Nabisco warehouse is one of the smallest warehouses in the district, measuring approximately 50 feet wide x 120 feet deep. It has a raised concrete foundation that extends from the front of the building to become a full-façade porch. The porch has a flat wood canopy supported by five lally poles; in between the poles is a non-historic metal balustrade. At each corner of the porch is an inset set of concrete steps.

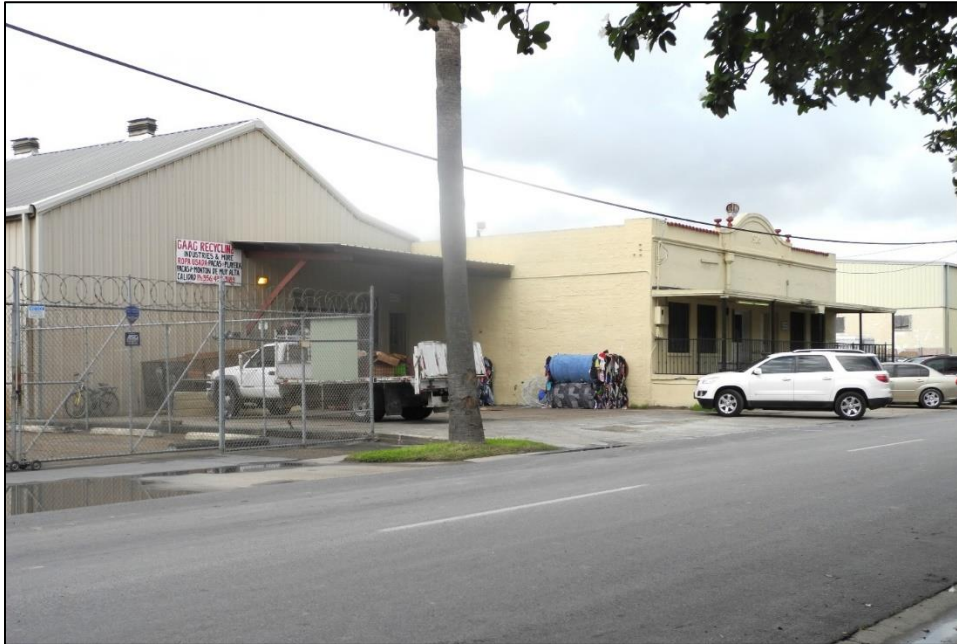
PHOTO 21: 720 E. Fronton Street (Resources 11 and 10 left to right), front/north elevations, facing west.

The warehouse building in the 700 block of E. Fronton was constructed as a wood frame building with metal walls dating to c.1912. Around 1990, it was re-sheathed on its north and east elevations with new metal siding and a new metal roof. It has a footprint measuring approximately 48 feet across and 80 feet deep. It may have been internally connected to the adjacent warehouse at 720 E. Fronton Street at that time. Its front elevation is set back about 30 feet from the front elevation of that next-door building. The storage building sits on a concrete foundation and has a concrete driveway in front. The front-gabled roof has two roof pitches on its west side where it connects to 720 E. Fronton. In the west corner of the front elevation is a flat-roofed metal canopy that shelters one loading bay door and a single pedestrian entry.

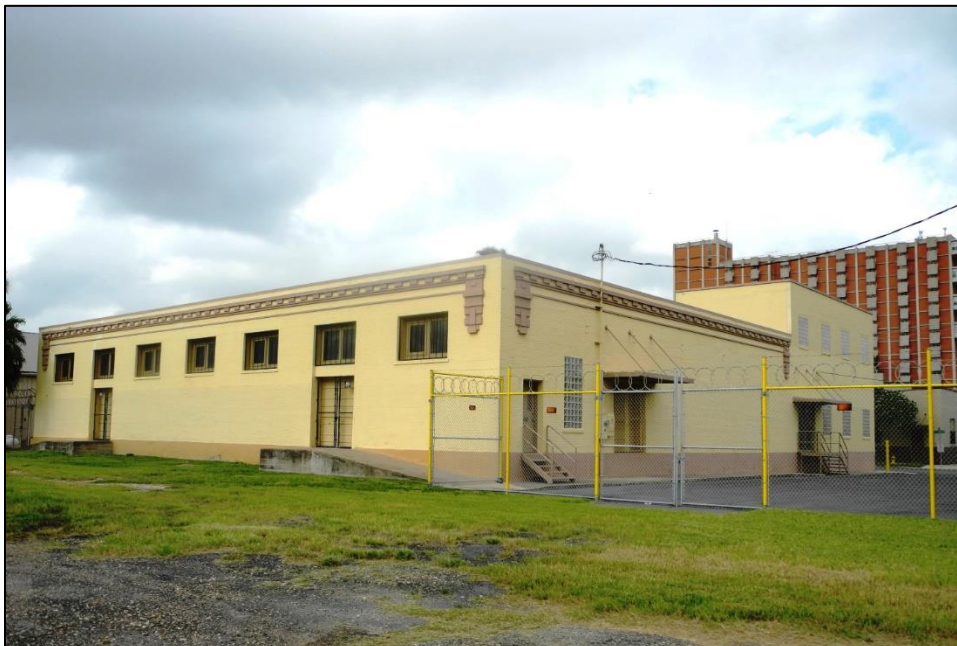
PHOTO 22: 730 E. Fronton Street (Resource 12), rear/south and east elevations, facing north.

The rear of the building originally had a single, full-façade loading dock, but it was replaced by two small docks with concrete ramps at either end of the elevation. The ramps lead to two original loading bays with original wood overhead doors and non-historic metal security screen doors. At the center of this elevation was another loading bay that was infilled. Above the doors are seven evenly-spaced clerestory windows with brick sills, original fenestrations, and replacement windows. Each window has two single-light sash, one of which appears to be fixed and the other operable. On the east side elevation is a single pedestrian entry accessed by a set of metal stairs, and a loading bay door with a flat metal awning. Between the doors is a rectangular window opening that has been infilled with glass block.

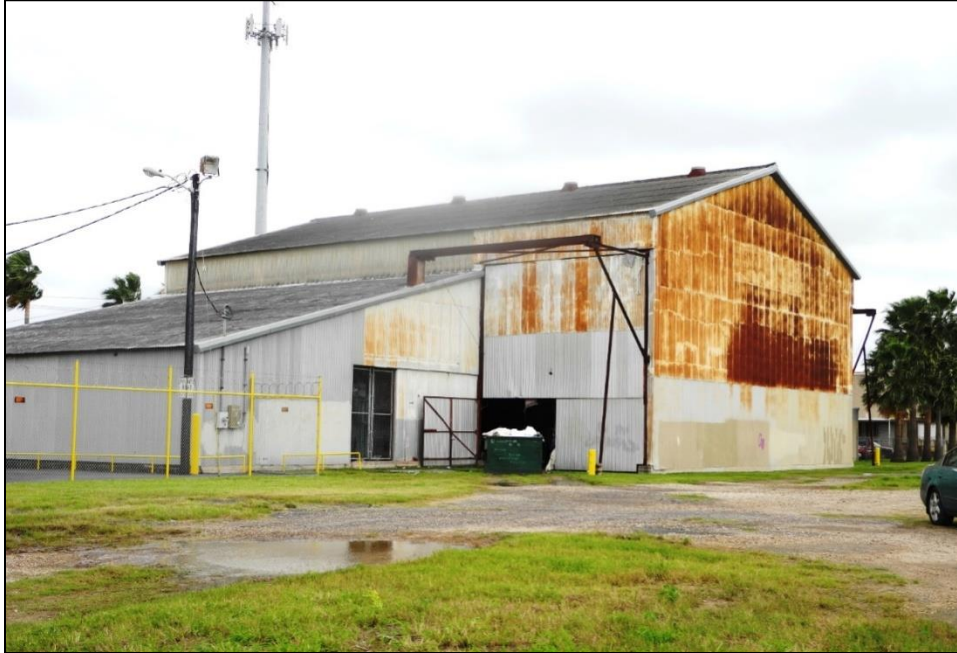
PHOTO 23: 800 E. Fronton Street (Resource 13), rear/south elevation, facing east.

The Alamo Iron Works Supply Warehouse is a large steel-framed building with a “barn-like” appearance. It is composed of a tall central section flanked by two one-story shed wings that are flush with the central section’s front façade. The building sits on a slightly raised concrete foundation and its walls and roof are clad in its original corrugated metal siding. The central building volume measures approximately 66 feet across and 86 feet deep, and each of the side wings are approximately 46 feet across and 62 feet deep. The central section is two stories in height and has a front-gabled roof and a wide loading bay door on its front elevation. Two concrete ramps lead to the bay door. A non-historic, metal-clad canopy shelters the loading ramps and door.

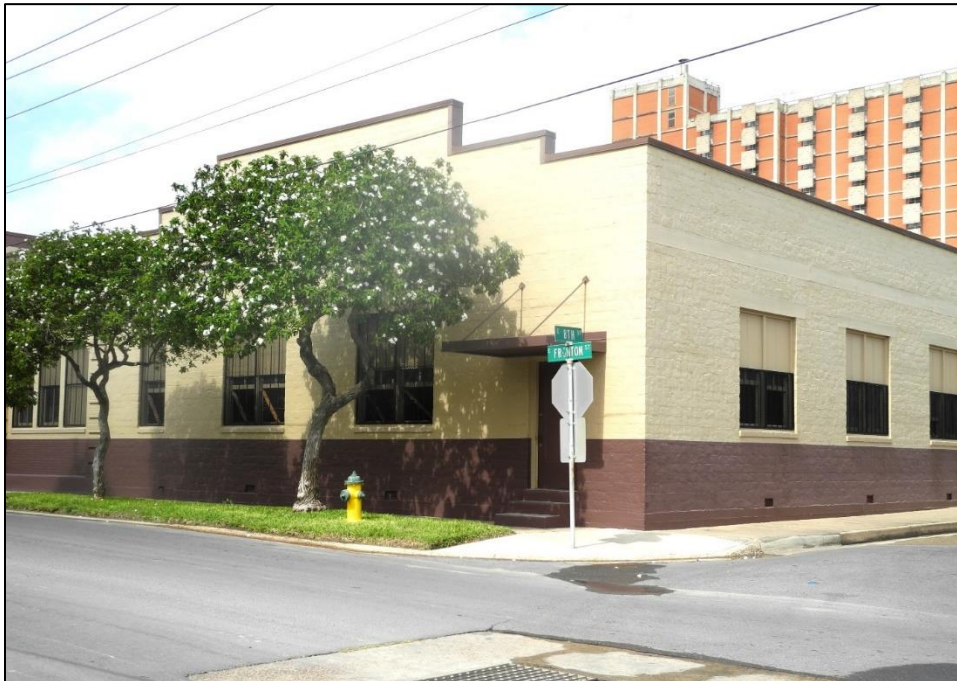
PHOTO 24: 759 E. Fronton Street (Resource 14), front/south and east elevations, facing north.

The McNair Clothing Manufacturing Company building is a one-story factory and warehouse on the north side of E. Fronton Street. The building measures about 44 feet long along Fronton Street and about 120 feet deep. It has brick walls, a flat roof with low parapet, and a concrete foundation that raises its floor only a few inches above grade. The building replaced a c. 1910 dwelling associated with the Sugarman warehouse (Resource 14) on the site in 1933. It shares party walls with the earlier 1910 McNair Shirt Factory building to the east and with the later McNair Clothing Co. factory built c. 1954 to the west. Only the front and rear elevations of the building are visible. Though the three buildings are now internally connected, they were built in separate construction campaigns independent from one another as evidenced by the different designs of their principal facades (E. Fronton Street).

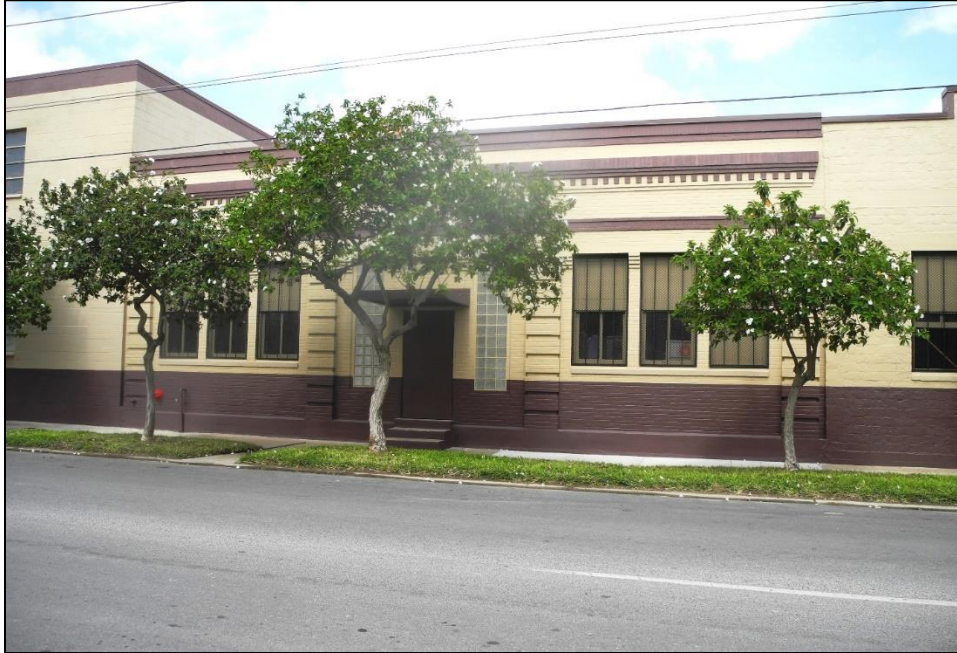
PHOTO 25: 749 E. Fronton Street (Resource 15), front/south elevation, facing northeast.

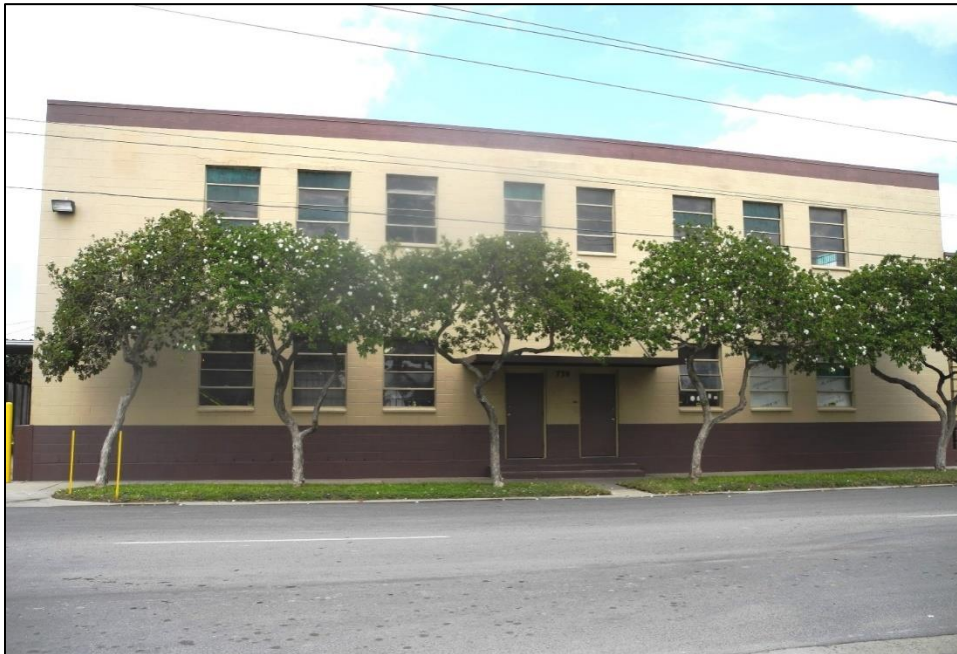
PHOTO 26: 739 E. Fronton Street (Resource 16), front/south elevation, facing northeast.

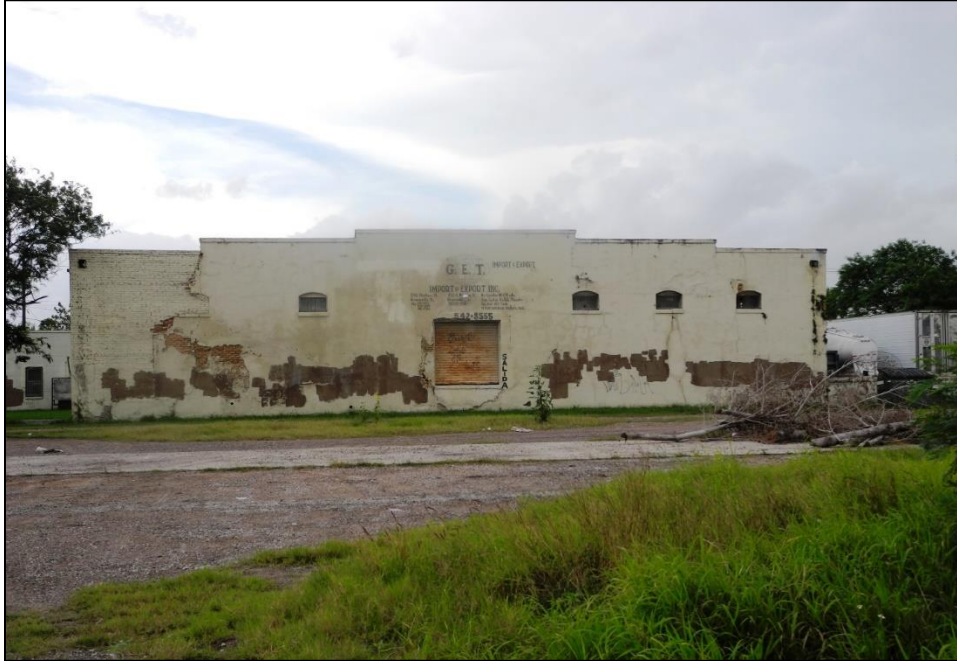
PHOTO 29: 430A E. Fronton Street (Resource 4), rear (freight line) elevation, facing northeast.

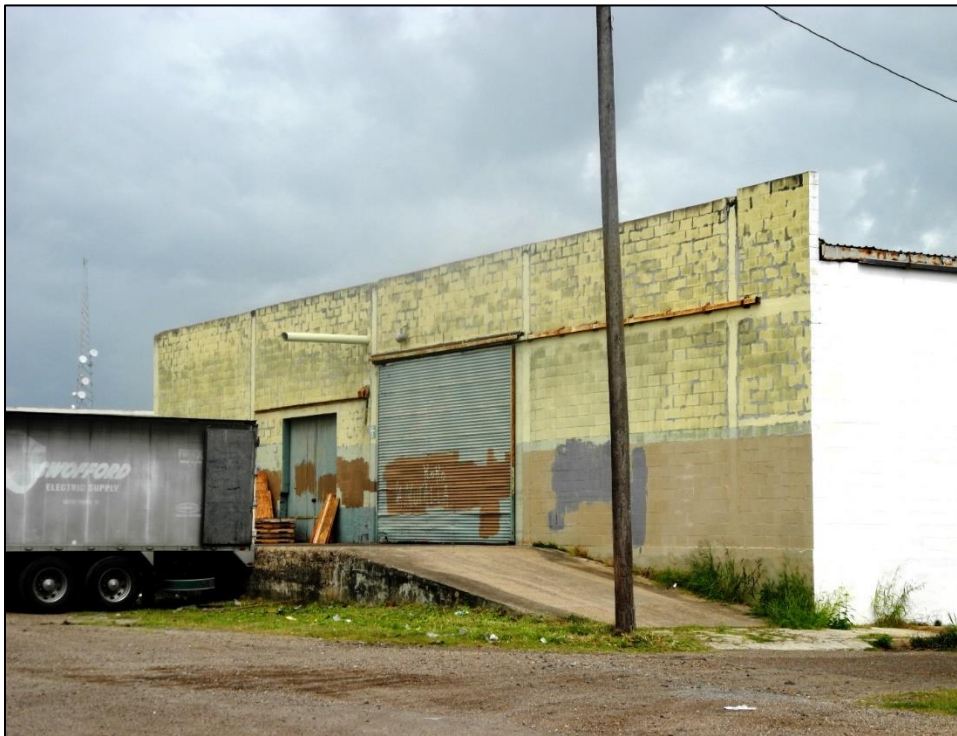
PHOTO 30: 454 E. Fronton Street (Resource 5), rear (freight line) south elevation, facing north/northwest.

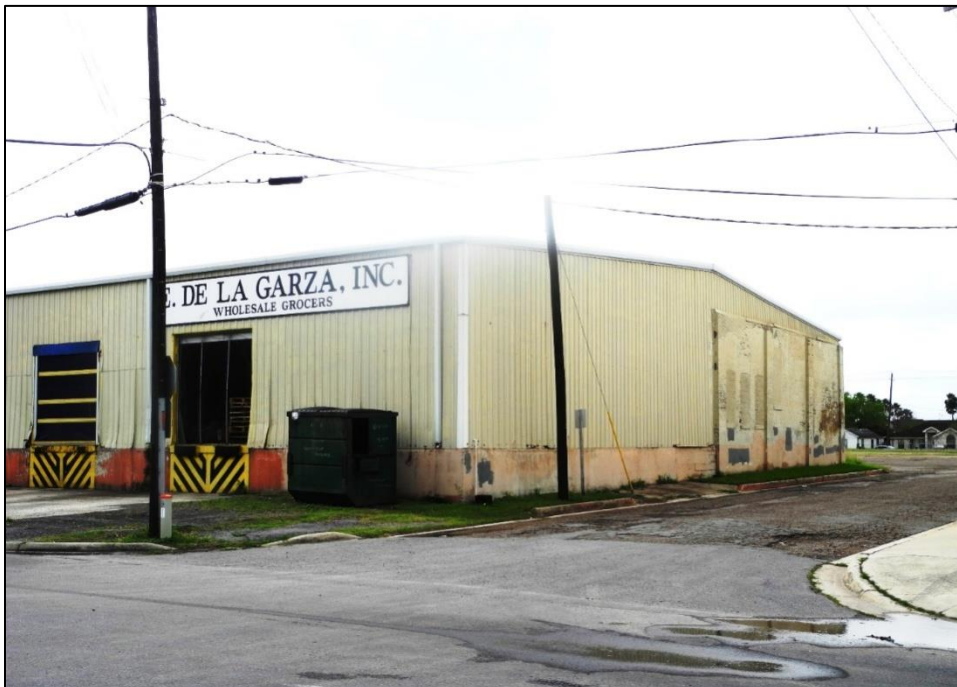
PHOTO 32: 600 block E. Fronton Street (Resource 8), north and west elevations with c. 1906 original building volume visible on the right, facing south.

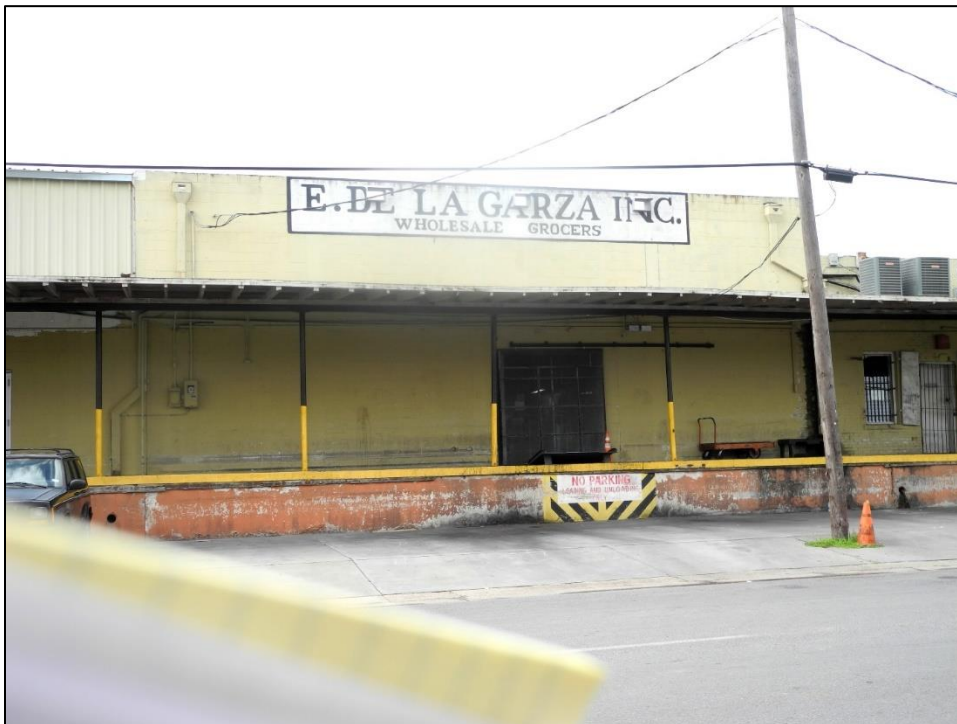
PHOTO 34: 634 E. Fronton Street (Resource 9), c. 1956 building volume front/north elevation, facing southwest.

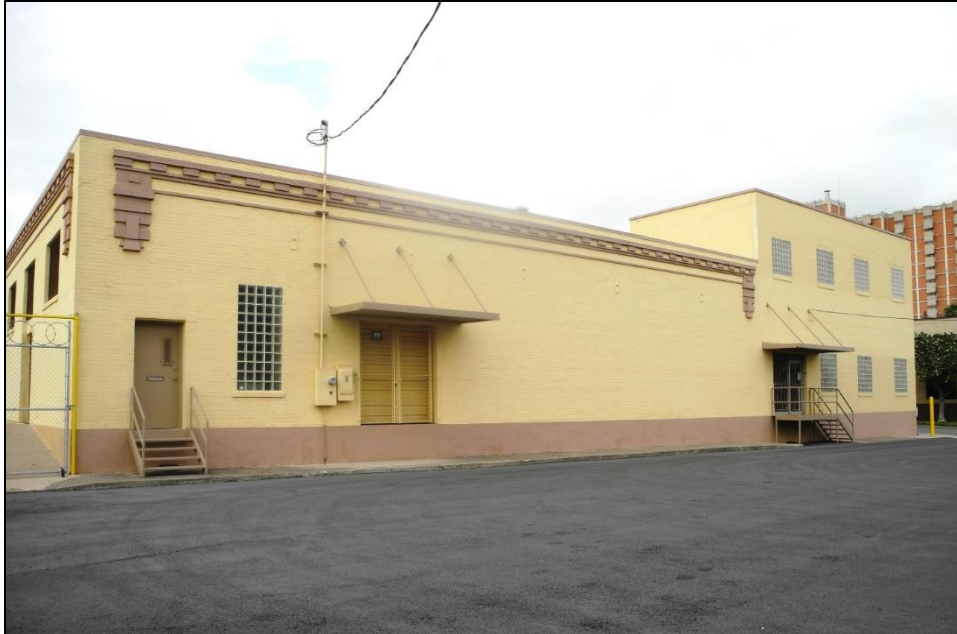
PHOTO 35: 730 E. Fronton Street (Resource 12), east side elevation with c. 1925 office volume on right, facing north.

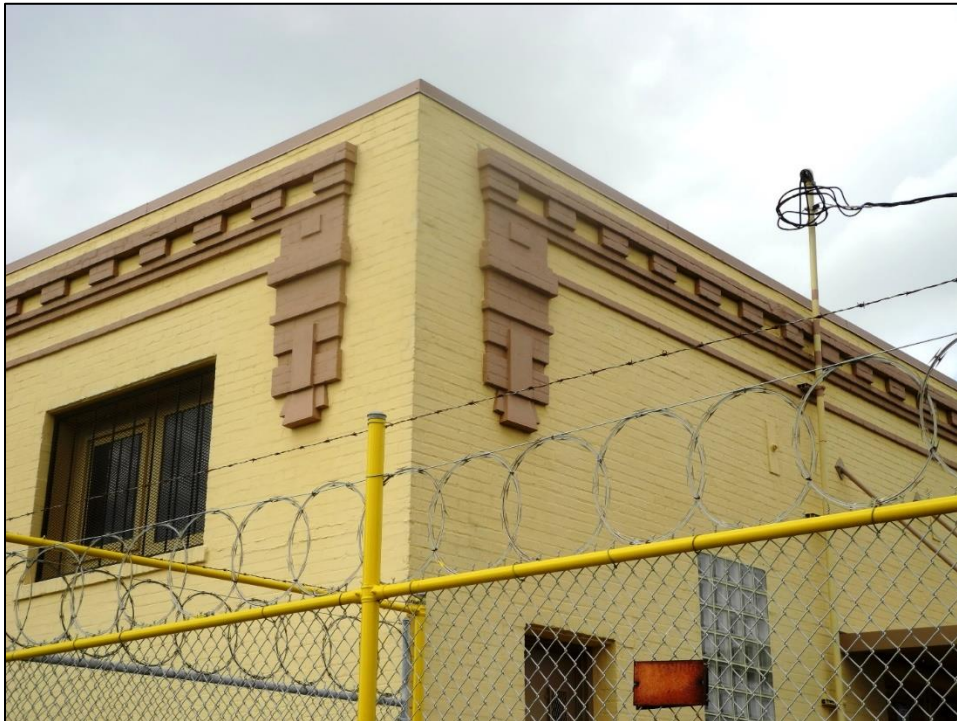
PHOTO 36: 730 E. Fronton Street (Resource 12), brickwork detail at southeast corner, facing north.

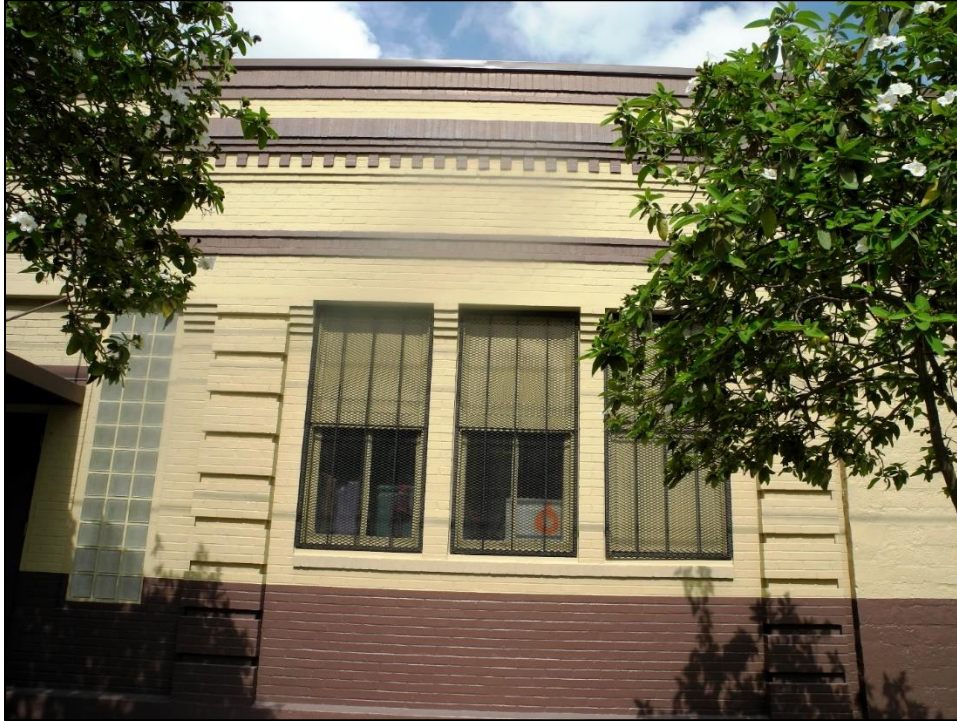
PHOTO 37: 749 E. Fronton Street (Resource 15), brickwork detail, front/south elevation.

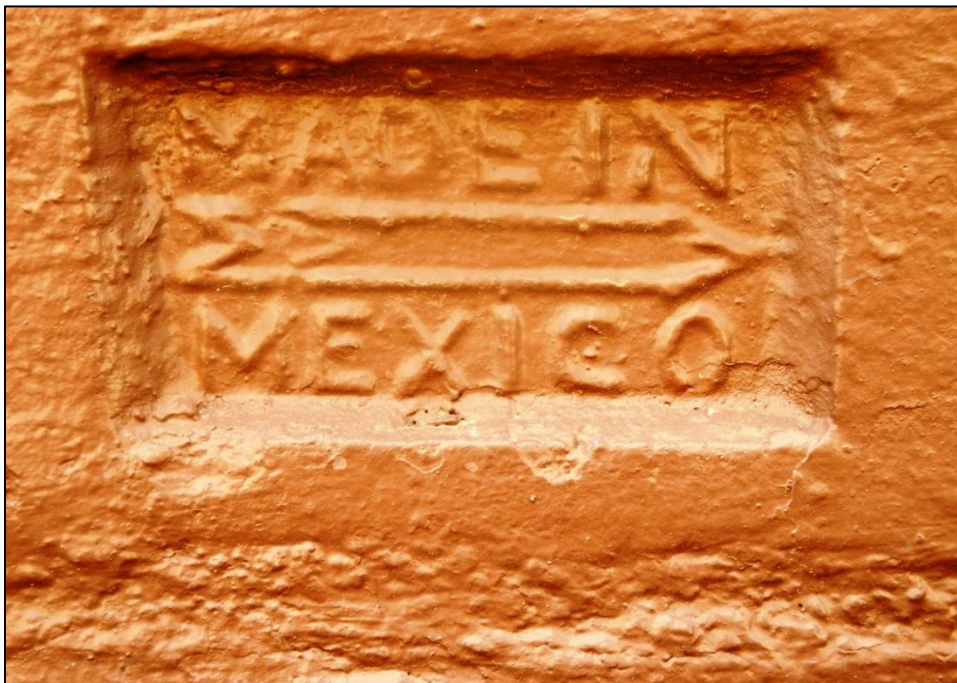
PHOTO 38: 749 E. Fronton Street (Resource 15), brick detail, rear/north elevation.

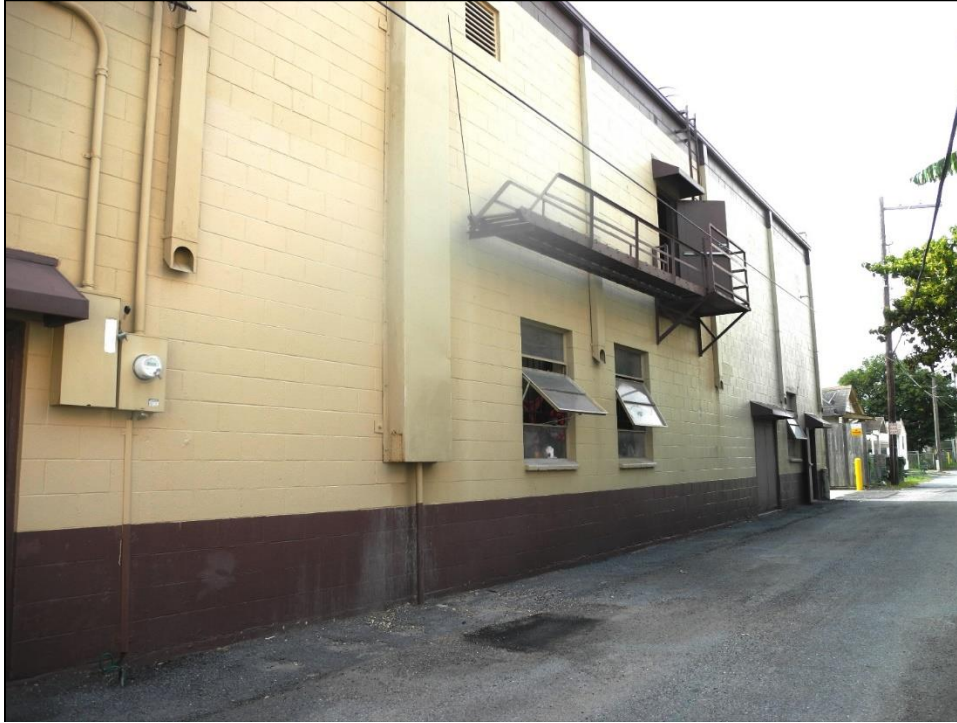
PHOTO 39: 739 E. Fronton Street (Resource 16), rear/north elevation, facing west/southwest.
